TITLE NAVIGATION - 9500 POUND ZERO FUEL WEIGHT INSTALLATION

To allow a zero fuel weight of 9500 pounds.

34-15  
Page 1 of 9  
Jun 11/73

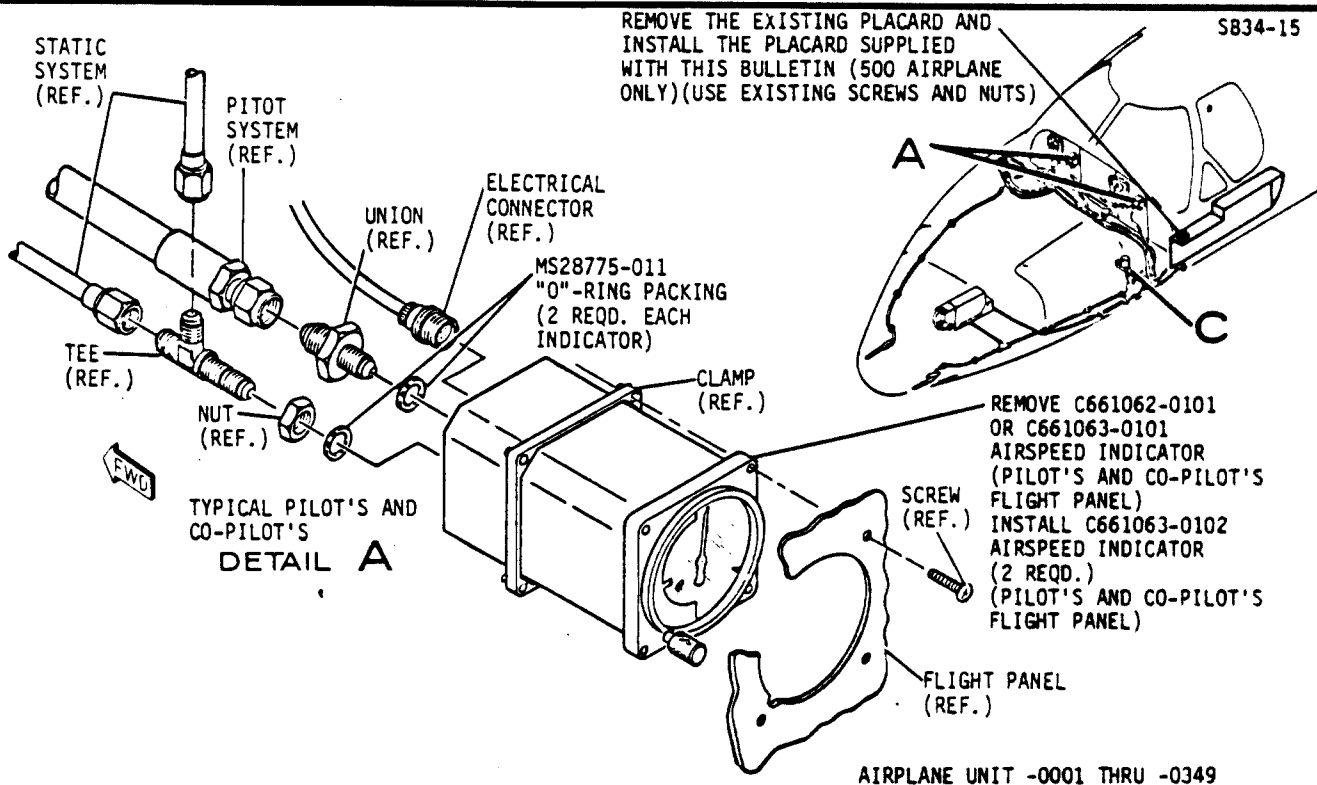
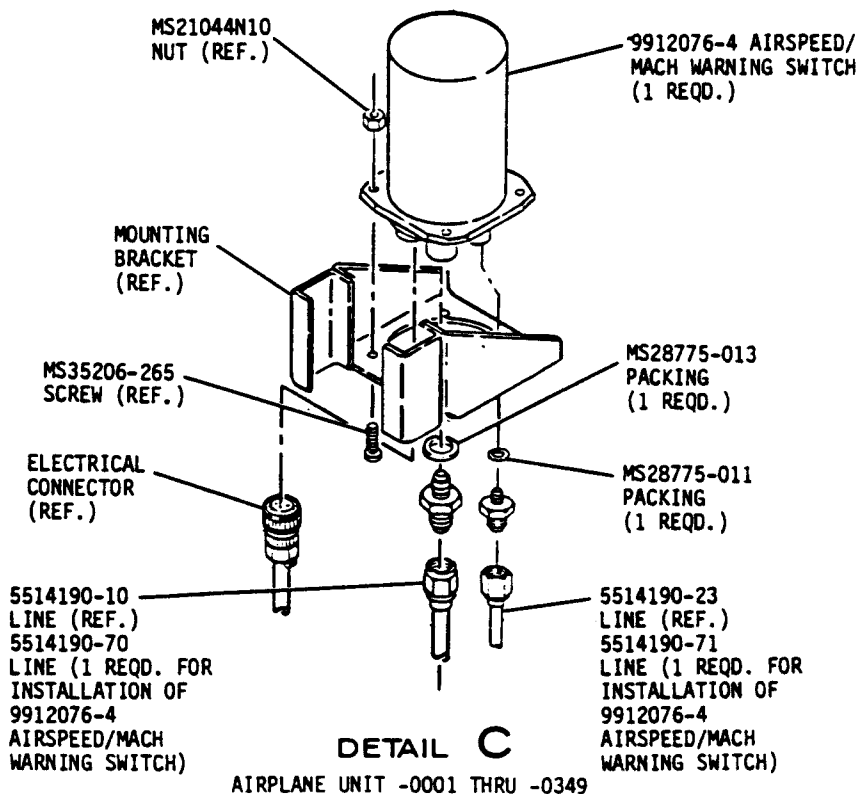
Figure 1. 9500 Pound Zero Fuel Weight Option Installation (Sheet 1 of 2)

2. Remove both the existing mach/airspeed indicators. (Refer to the Maintenance Manual, Chapter 34, Mach/Airspeed Indicators - Removal/Installation.)
  - A. (Refer to Figure 1, Sheet 1, Detail A.) Airplanes -0001 thru -0349, remove the C661062-0101 or C661063-0101 Mach/Airspeed Indicators left and right. Retain removed hardware. Discard packings.

3. Install new mach/airspeed indicators. (Refer to the Maintenance Manual, Chapter 34, Mach/Airspeed Indicators - Removal/Installation.)
  - A. (Refer to Figure 1, Sheet 1, Detail A.) Airplanes -0001 thru -0349, install C661063-0102 Mach/Airspeed Indicators in place of removed C661062-0101 or C661063-0101 indicators, using existing hardware and new packings furnished in this bulletin.

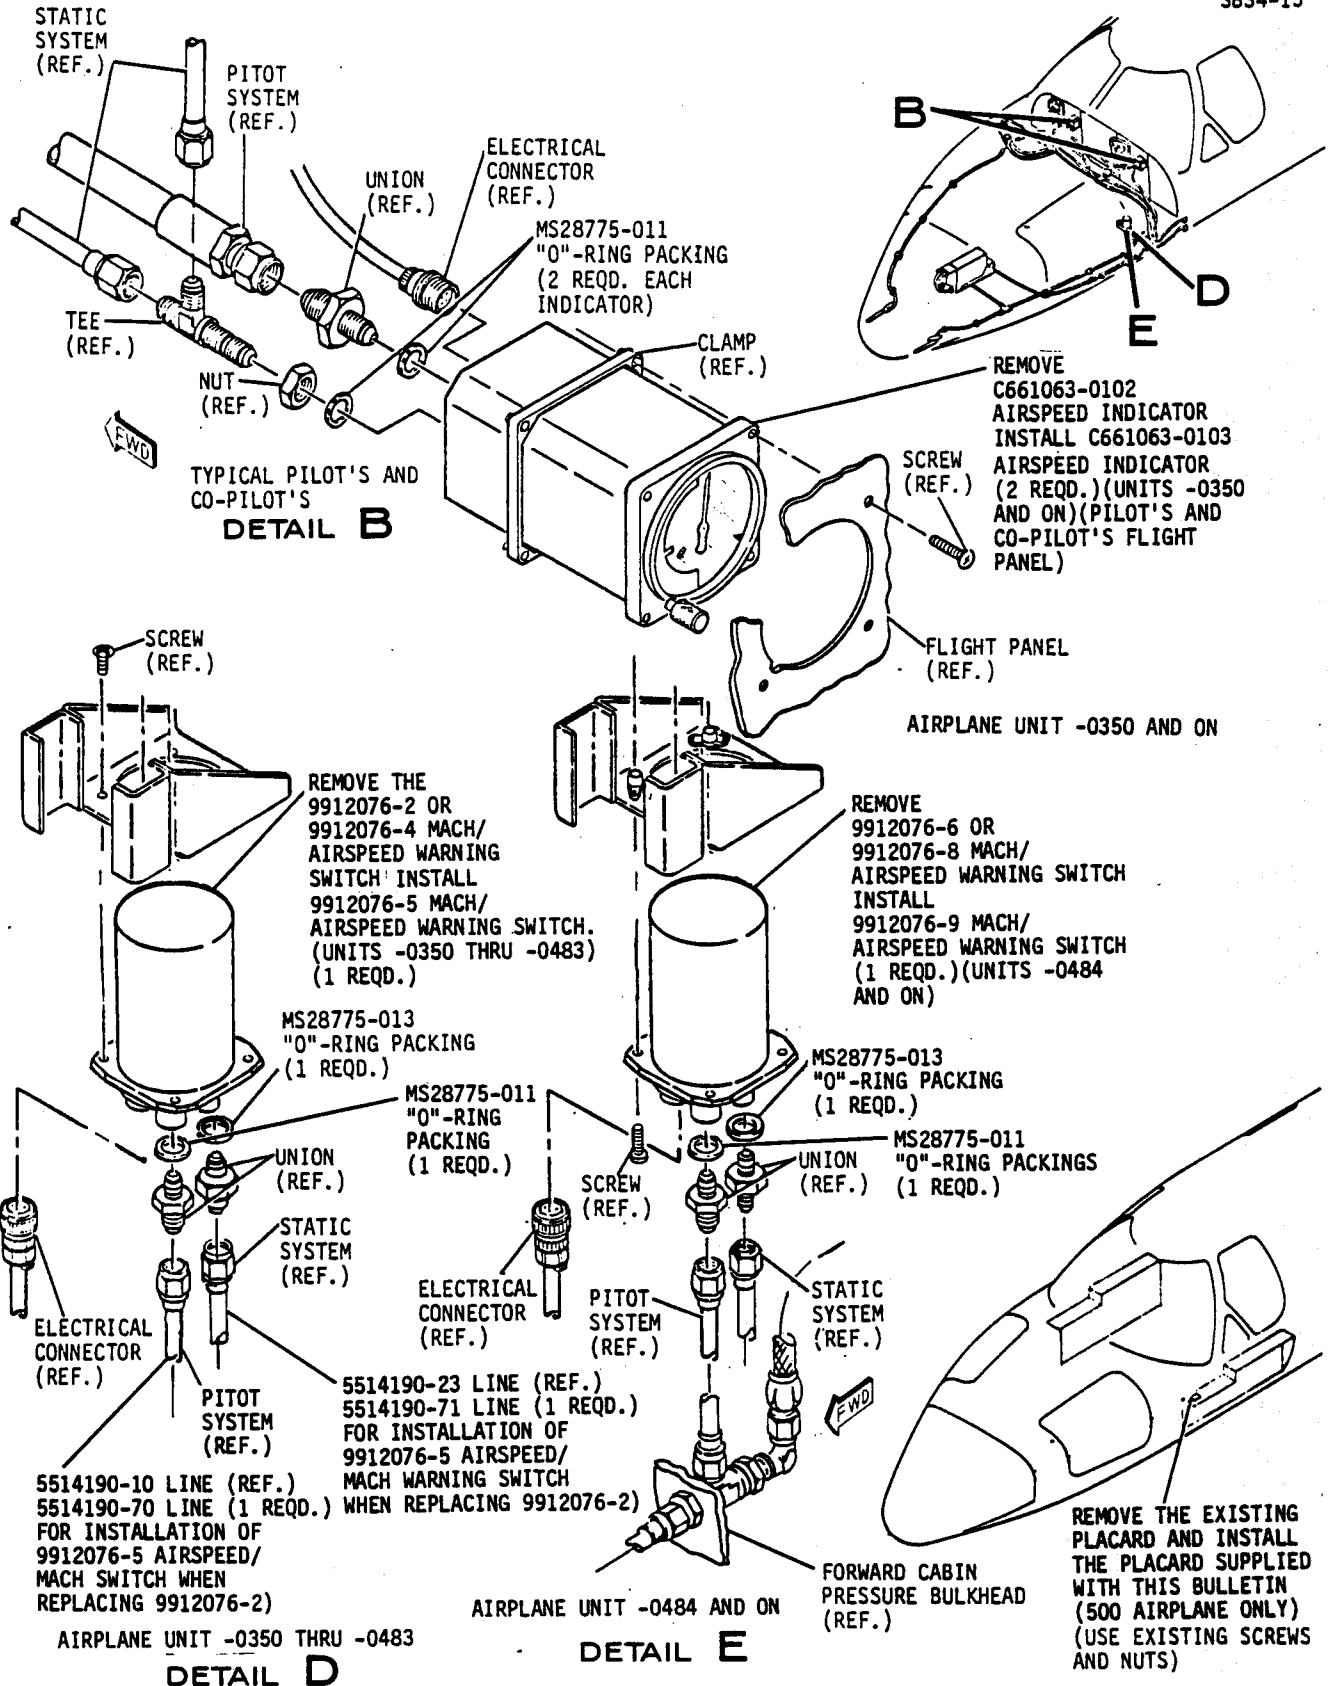
Figure 1. 9500 Pound Zero Fuel Weight Option Installation (Sheet 2)

- B. (Refer to Figure 1, Sheet 2, Detail B.) Airplanes -0350 thru -0689, remove the C661063-0102 Mach/Airspeed Indicators left and right. Retain removed hardware. Discard packings.

- B. (Refer to Figure 1, Sheet 2, Detail B.) Airplanes -0350 thru -0689, install C661063-0103 Mach/Airspeed Indicators in place of removed C661063-0102 indicators, using existing hardware and new packings furnished in this bulletin.
